A Major New E-Resource for Nonstructural Risk Reduction

The statements above reveal some of the impetus behind the development of an extensive new guide to mitigating nonstructural earthquake damage, *Reducing the Risks of Nonstructural Earthquake Damage—A Practical Guide* (Fourth Edition). Published early this year by the Federal Emergency Management Agency (FEMA) and known by its publication number, FEMA E-74, this 755-page resource updates guidance last issued in 1994.

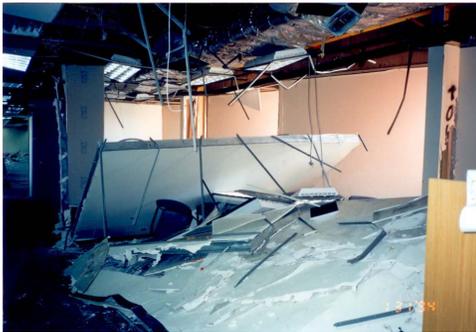
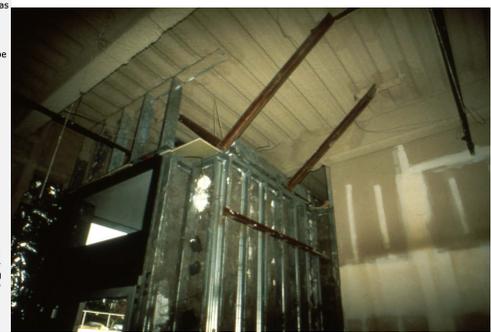
Photos and illustration from the light interior partition wall component example in FEMA E-74. Left photo (courtesy of Wiss, Janney, Elstner Associates) shows failure of inadequately braced partial height partitions in the 1994 Northridge earthquake. Center detail illustrates seismic mitigation solution for nonstructural, partial height stud wall. Photo on right (courtesy of Degenkolb Engineers) shows appropriately braced partial height stud partition.

mitigated. The examples include information about the typical causes of damage to the component, accompanied by photographs of such damage from earthquakes over the past 40 years. This is followed by information about how to mitigate the damage, accompanied by detailed illustrations or photographs of anchoring, bracing, or other protective solutions commonly used for the component. Two-letter codes indicate whether the solution can be implemented by a handyperson or maintenance personnel, is likely to require a contractor, or should be designed by an engineer. The examples are grouped into subcategories under the main categories described above (architectural, MEP, FF&E and contents). Each example can be individually downloaded from the [online version](#) of the guide.
