Getting in GEER for New Zealand

Joint Reconnaissance of the 2011 Christchurch Earthquake

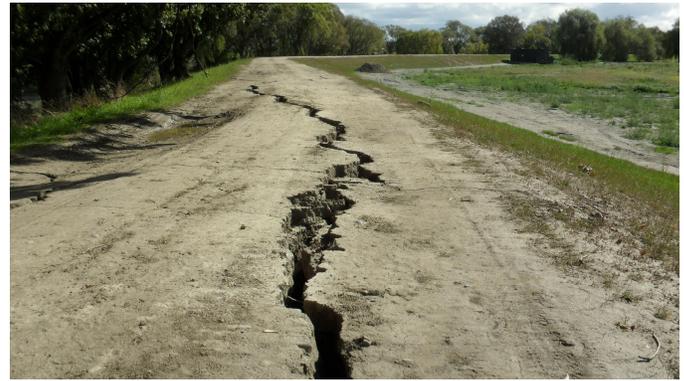
A lateral spread crack running along the crest of a levee in Kaiapoi, just north of Christchurch. Courtesy of R. Green, Virginia Tech.
